PJ'S BASS LAKE DAM  
ST FRANCOIS COUNTY, MISSOURI  
MO 31189

## PHASE 1 INSPECTION REPORT NATIONAL DAM SAFETY INSPECTION

JUNE 1981

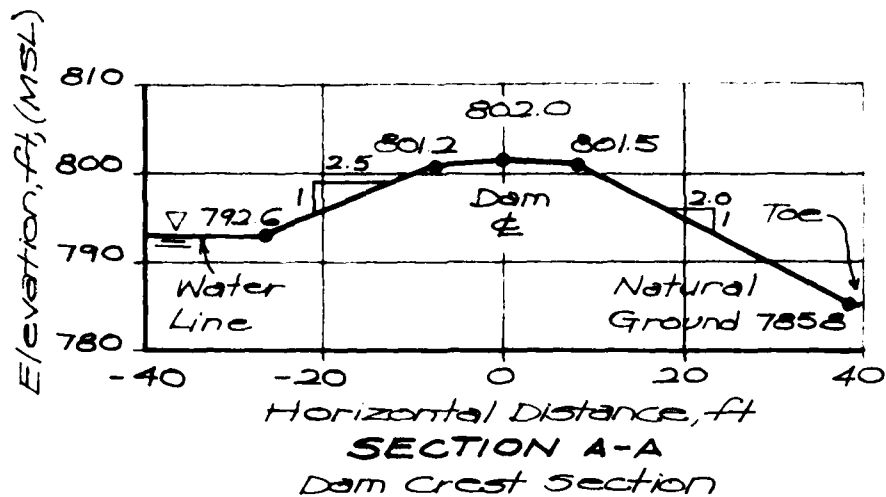
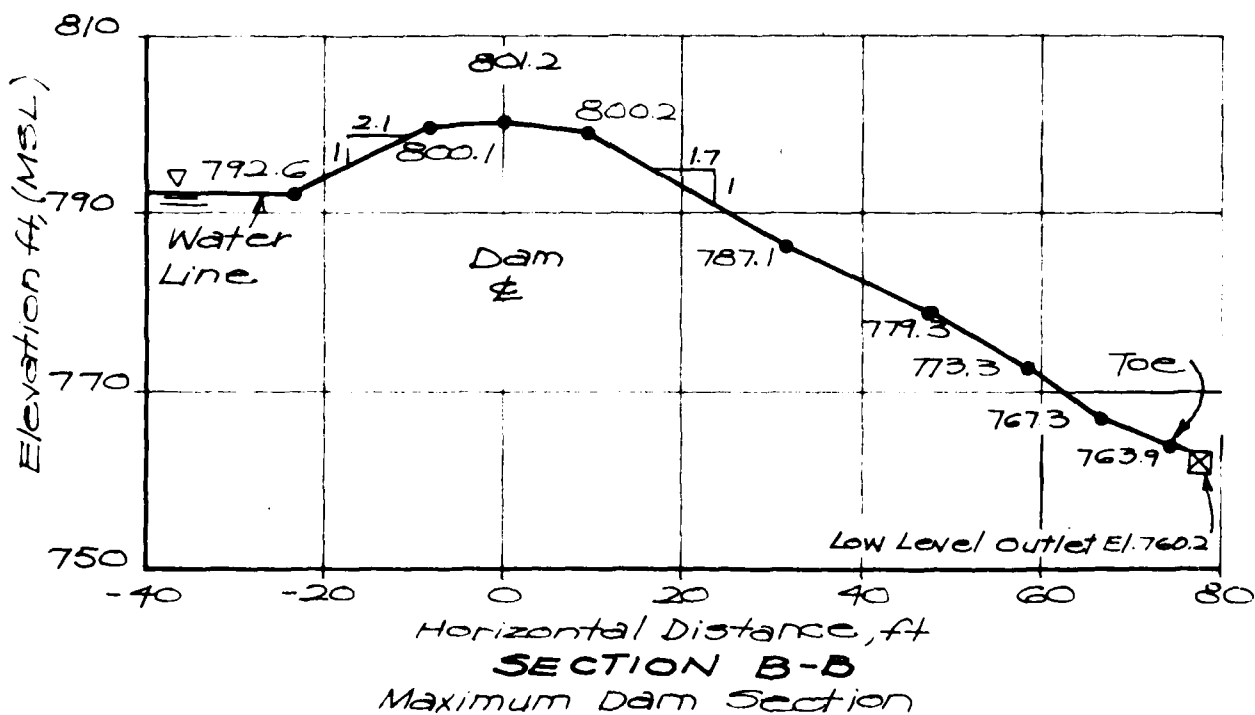
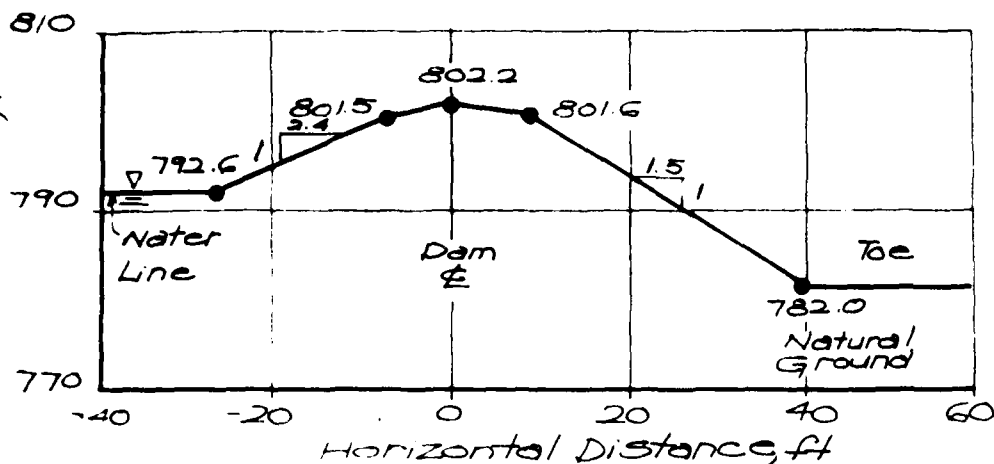
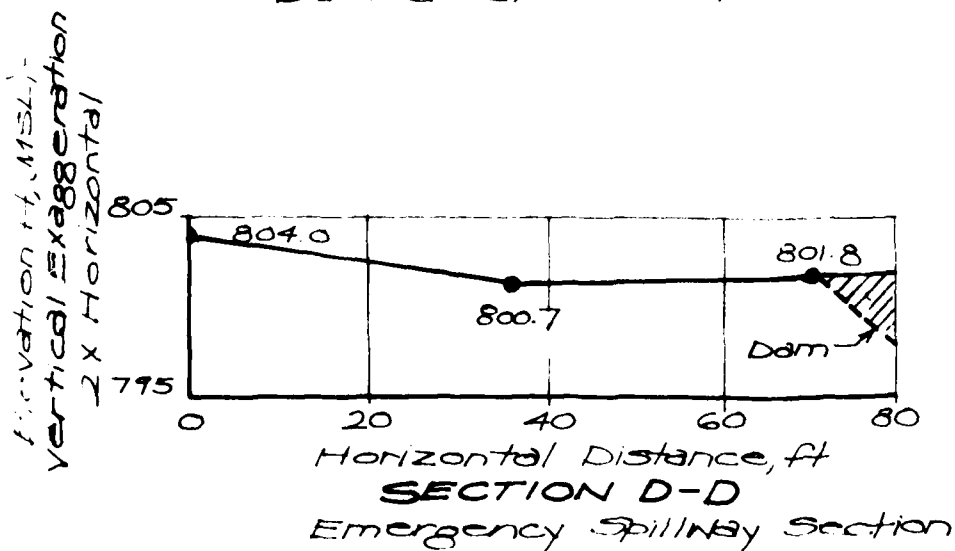
Fig. 3-A

The visual inspection indicated some settlement may have occurred leaving the center of the dam crest lower than the ends. The field survey (Fig. 3A) shows the center to be approximately 0.6 ft lower than the right end and more than 2 ft lower than the left end of the dam. The horizontal alignment of the crest does not appear disturbed, although this is difficult to assess due to the curving downstream configuration.

- a. Visual inspection. The visual inspection identified no signs of cracking, sinkhole development, or animal burrows on the embankment. The field survey noted minor settlement had occurred near the center of the embankment (Fig. 3A). Seepage was noted at the toe of the dam. This was reported by Mr Hunt as a spring which existed prior to the building of the dam. If this is the case, it does not appear that any special precaution was taken during construction to install a filter over the spring. Total seepage flow was estimated at 5 gal/min. The seepage water did not appear to be transporting any soil, and was not considered to pose a hazard to the stability of the dam at the time of the inspection.
